Mobile Pentium® II Processor Specification Update

Release Date: October 1999

Order Number: 243887-014

The Mobile Pentium® II processor or the Intel® Pentium® II Processor Mobile Module may contain design defects or errors known as errata which may cause the product to deviate from published specifications. Current characterized errata are documented in this Specification Update.

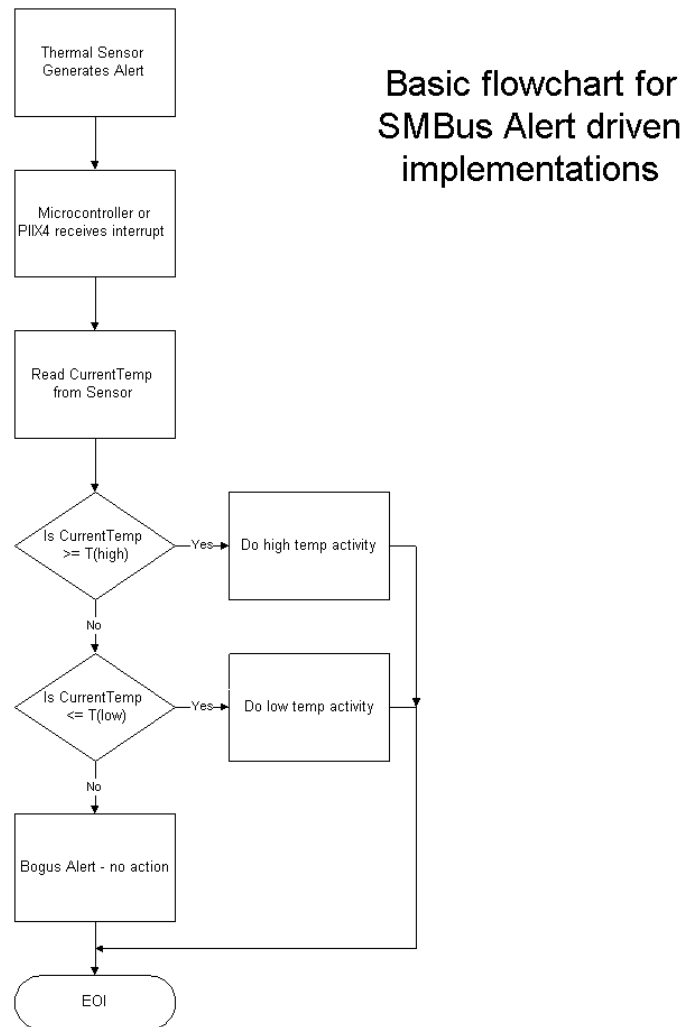
Figure 2. Workaround Flowchart: SMBALERT#-Driven System

Under the conditions described below, the thermal sensor incorrectly generates the SMBALERT# interrupt. All of the following conditions must be met to trigger a false interrupt:

1. Before servicing an interrupt from the thermal sensor, read and compare the processor thermal reading with the threshold limits (T_{HIGH} or T_{LOW}). Figures 2 and 3 provide basic flowcharts for the implementation of this workaround in an interrupt driven system.
2. If the firmware implemented polls the Status Register only, then before taking any action, re-read the temperature register and do a comparison with the alarm threshold limits (T_{HIGH} or T_{LOW}) to determine if the value is actually still within the temperature window.

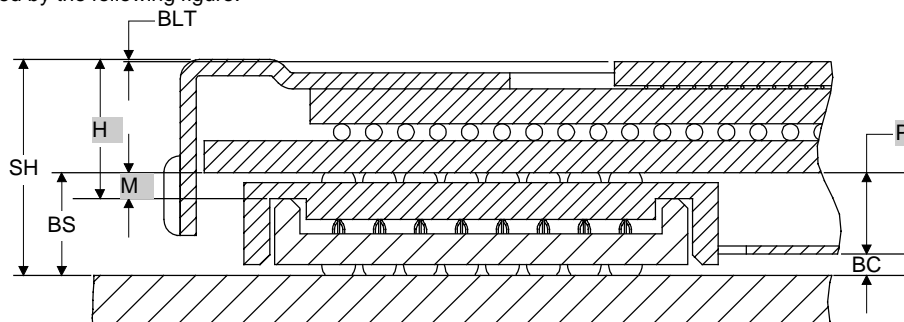
Figure 5.6. Cross Sectional View with Vertical Dimensions

B1. Mislabeled Vertical Dimension Parameters

Figure 5.6 in the *Mobile Pentium® II Processor at 233 MHz, 266 MHz, and 300 MHz* datasheet should be replaced by the following figure:

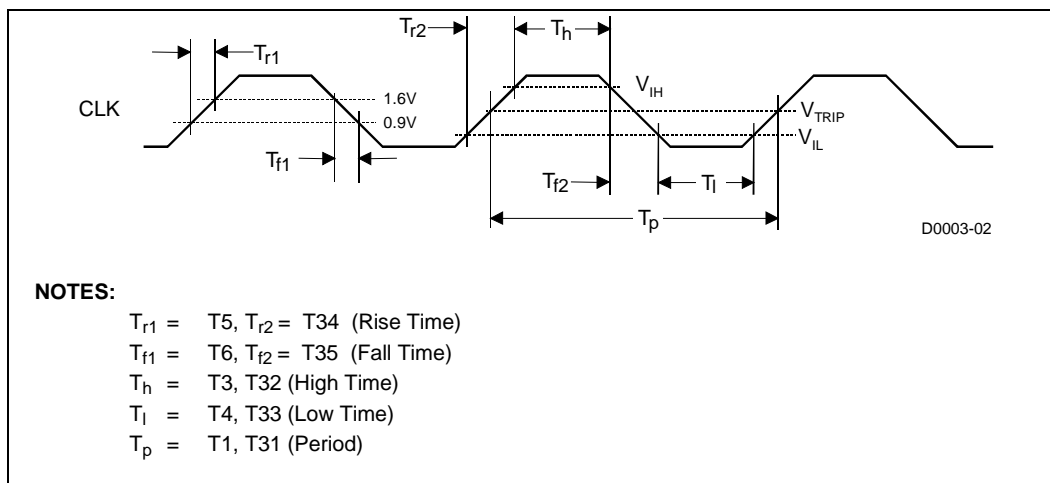
Figure 3.3 Generic Clock Waveform

Figure 3.3 in *Mobile Pentium® II Processor in Mini-Cartridge Package at 366 MHz, 333 MHz, 300PE MHz, and 266PE MHz* datasheet (Order Number 245108), and the *Mobile Pentium® II Processor in BGA Package at 366 MHz, 333 MHz, 300PE MHz, and 266PE MHz* datasheet (Order Number 245106) has been updated. The following figure is to replace the ones in the above documents.

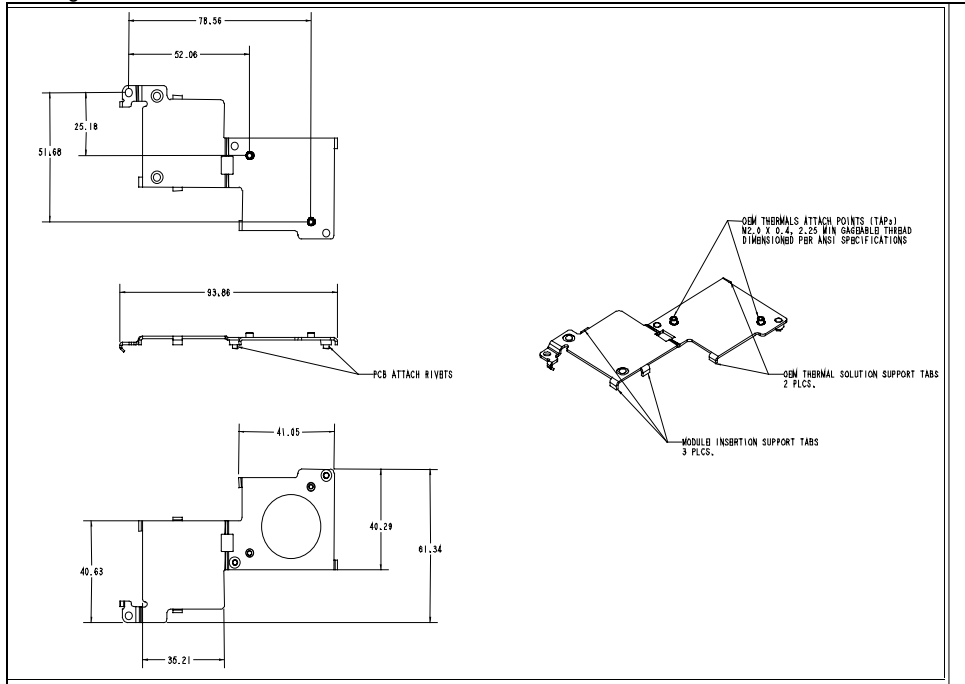
Figure 1. TAP Gageable Thread Clarification

OEM Thermal Attach Points (TAPs) M2.0 x 0.4, 2.25 min gageable thread dimensioned per ANSI specification.
